1 REPORT NO FHWA-CA-TL-7169-77-28		2 GOVERNMENT ACCESSION NO		3 RECIPIENT'S CATALOG NO	
4 TITLE AND SUBTITLE Design of An Air Quality Monitoring Trailer For Regional Air Quality Assessment				5 REPORT DATE December, 1977	
				6 PERFORMING ORGANIZATION CODE	
7 AUTHOR(S) Pinkerman, K.O., Sundquist, C.R., Shirley, E.C.				8 PERFORMING ORGANIZATION REPORT NO 19701-657169	
9 PERFORMING ORGANIZATION NAME AND ADDRESS Office of Transportation Laboratory California Department of Transportation Sacramento, CA 95819				10 WORK UNIT NO	
				11 CONTRACT OR GRANT NO A-8-27 19-603116	
12 SPONSORING AGENCY NAME AND ADDRESS California Department of Transportation Sacramento, California 95807				13 TYPE OF REPORT & PERIOD COVERED Interim 1975-76	
				14 SPONSORING AGENCY CODE	
15 SUPPLEMENTARY NOTES Conducted in cooperation with the U. S. Department of Transportation, Federal Highway Administration.. Study Title: Transportation Systems and Regional Air Quality

16. ABSTRACT <p>A vehicular impact test, 4700 lb (2130 kg) vehicle/61 mph (27 m/s)/26 degrees (0.46 rad), was conducted on a continuous New Jersey concrete median barrier (CMB) without a footing cast on an asphalt concrete surface. The test b

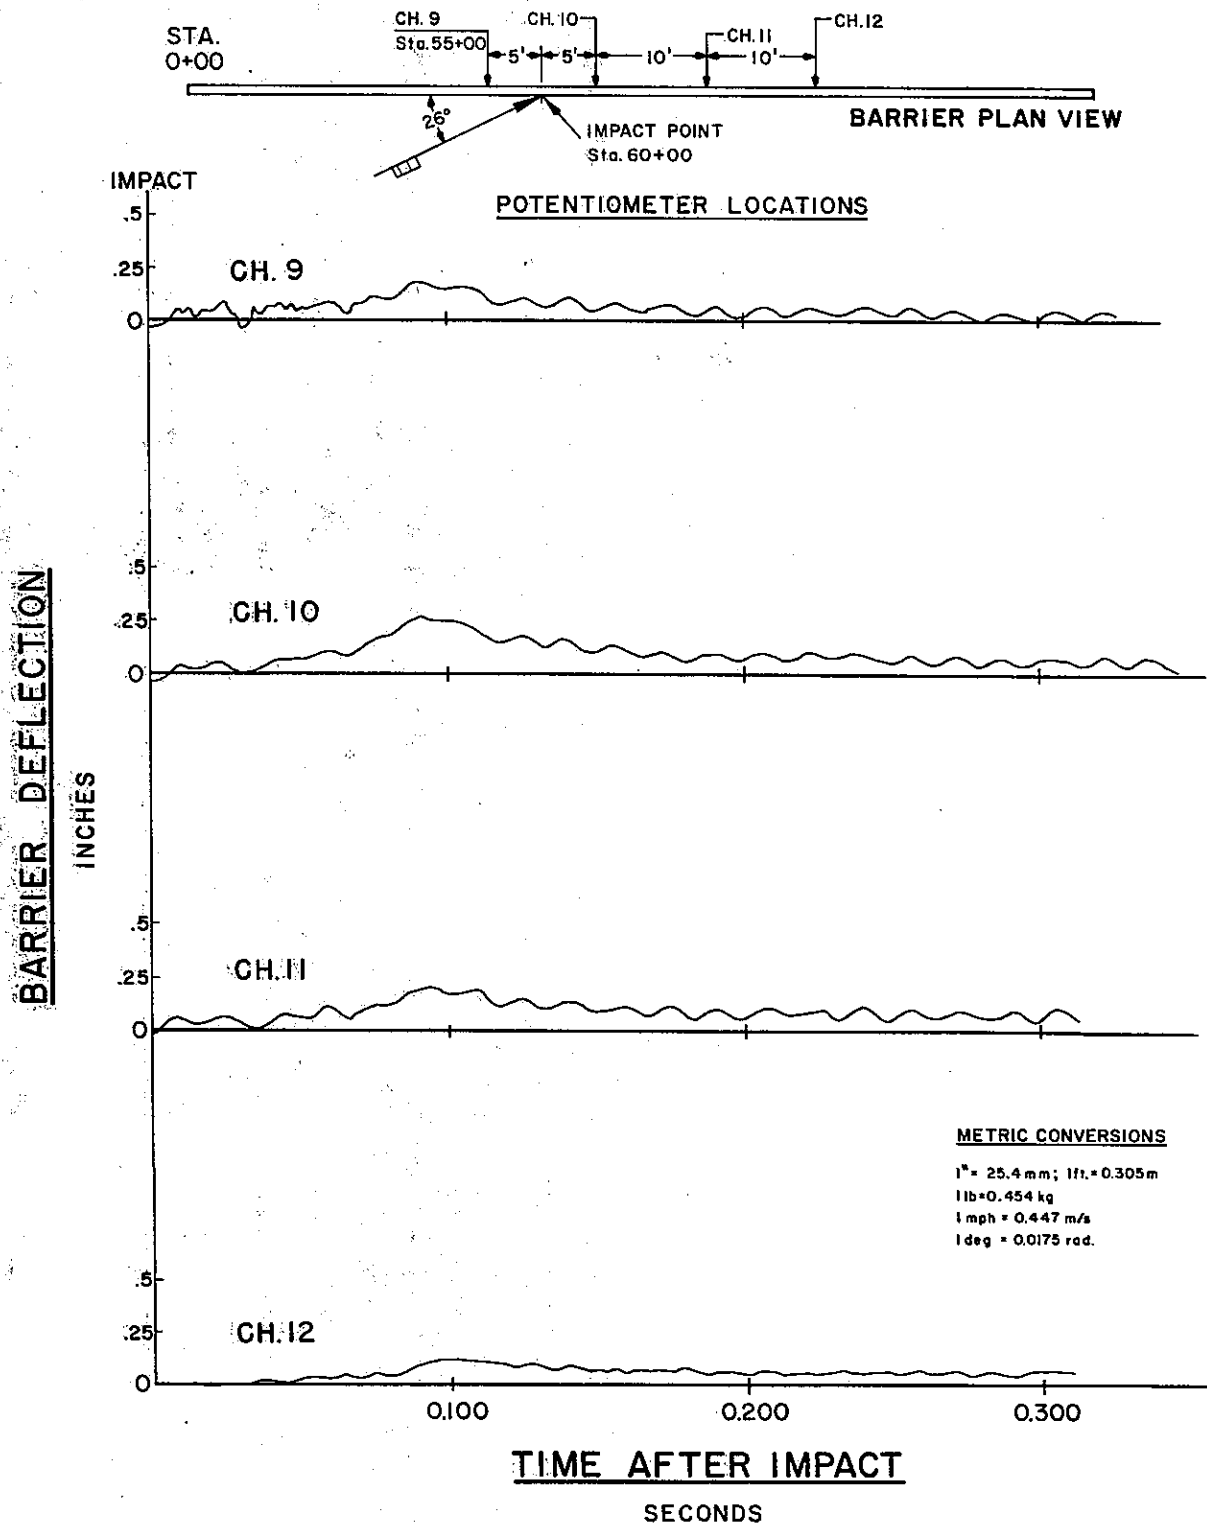
Figure 6A, BARRIER DEFLECTION VS. TIME *

TEST 321, 4700 lb. VEHICLE, 61 mph, 26°
CONTINUOUS CMB WITHOUT A FOOTING

* Middle ordinate plots of unfiltered data from Houston Deflection Potentiometers located 6 inches down from top of barrier.
